REPETITIVE LOSS AREA ANALYSIS

Chatham County, Georgia

May 2018

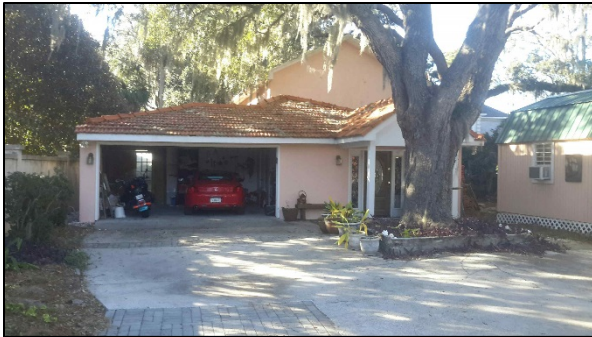
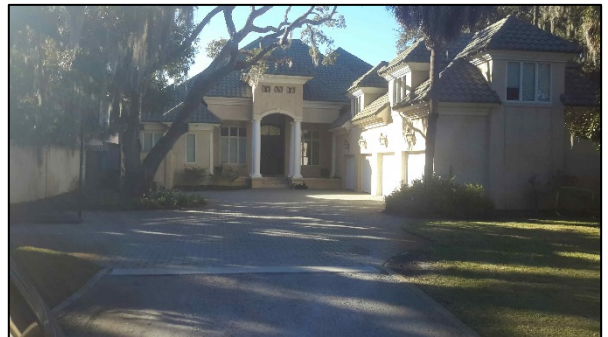
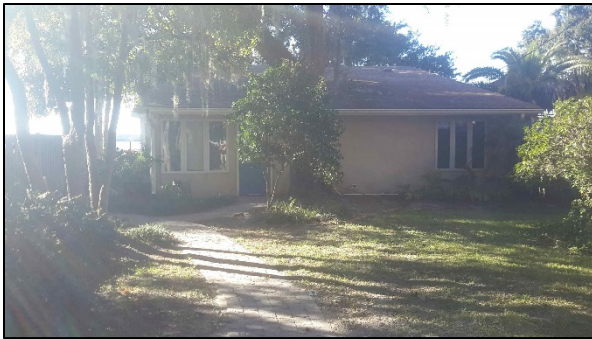
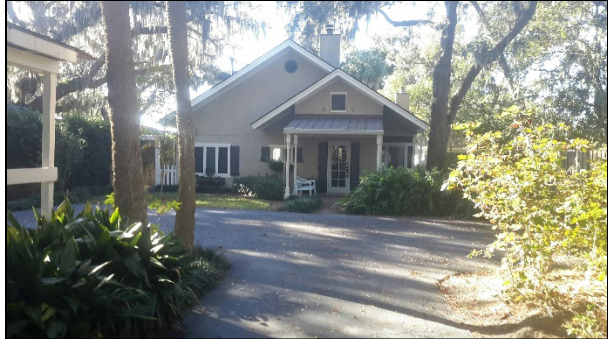
Example Properties in Repetitive Loss Area 1

Repetitive Loss Area 1 is completely located within the 100-yr floodplain. The Wilmington River is located just west of this Repetitive Loss Area. The area is residential with slab on grade foundation types. In general, HVAC systems were not visible from the street; therefore, it was not possible to determine if elevation should be considered as a mitigation measure in this particular area.

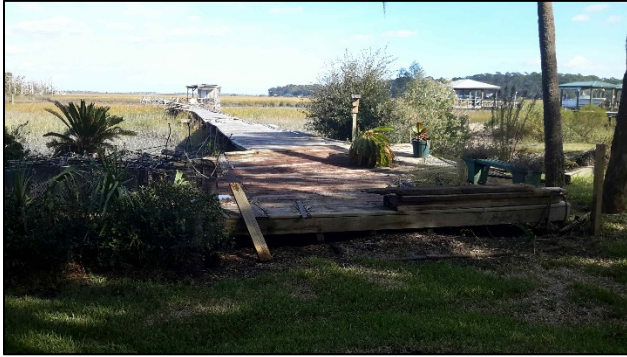
Flood damaged deck and dock

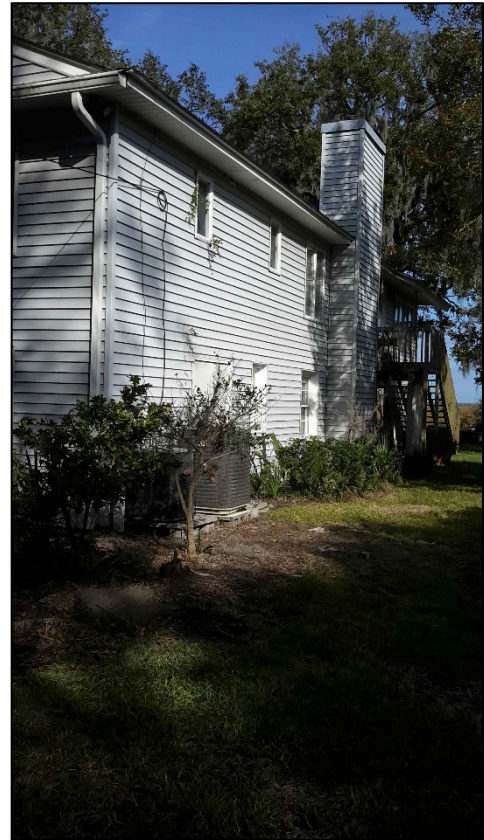
Repetitive Loss Area 7 is located completely within the 100-yr floodplain. Richardson Creek flows directly behind this Repetitive Loss Area with marshland in between. The area is residential with elevated foundation types and what appears to be fully enclosed, livable space underneath. HVAC systems were not elevated. One owner reported that minor flood damage during Hurricane Irma resulted in approximately 4 inches of water in the sun porch and one foot of water in the garage. This is reportedly the only flood damage at their home within 36 years. Another home had a wooden dock that appeared to have flood damage. There was also a grated yard inlet in the back yard. The home was currently unoccupied and interior repairs or renovations were under way. A neighbor said that the home has had numerous flood damage incidents.

Home with multiple reported incidents of flood damage does not have elevated HVAC

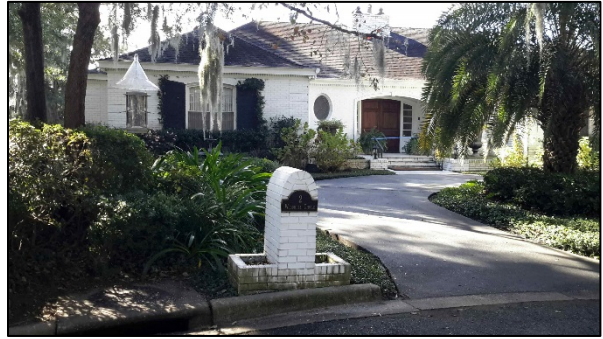
HVAC system not elevated

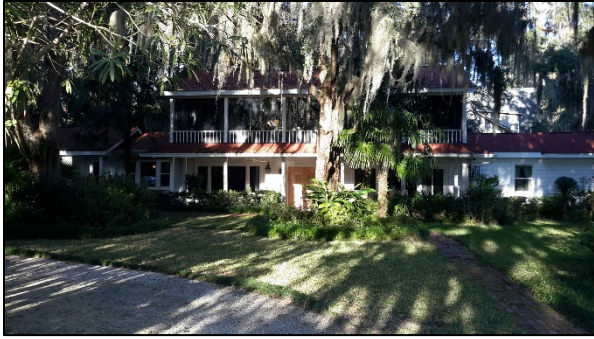
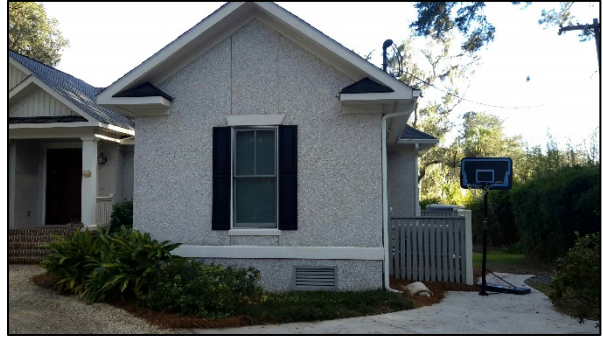
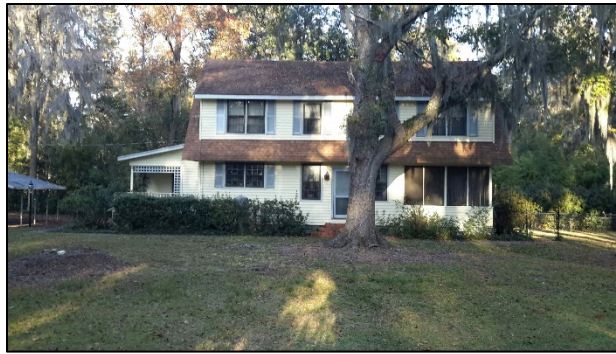
Example Properties in Repetitive Loss Area 13

Repetitive Loss Area 13 is located completely within the 100-yr floodplain. An unnamed channel flows directly south of this Repetitive Loss Area. The area is residential with a mix of crawlspace and slab on grade foundation types. One property owner indicated that the home as had flooding during the last two hurricanes as well as sometime in the past before current owner lived here. Some repairs are currently under way from flooding from last hurricane.

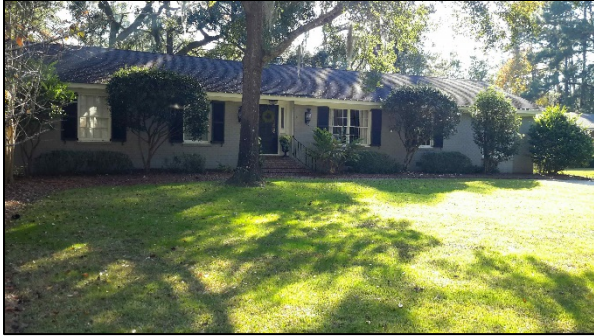
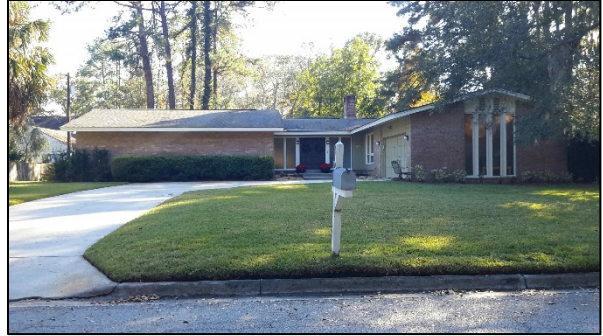
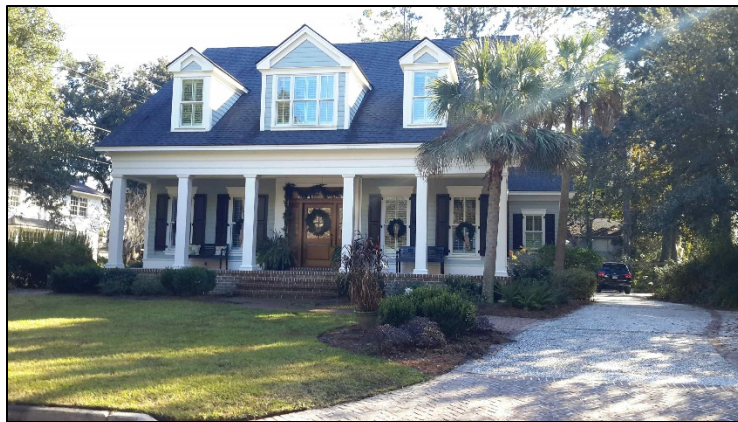
Example Properties in Repetitive Loss Area 14

Repetitive Loss Area 14 is located completely within the 100-yr floodplain. The Intracoastal Waterway flows directly south of this Repetitive Loss Area. The area is residential with a mix of crawlspace and slab on grade foundation types. HVAC systems are not elevated.

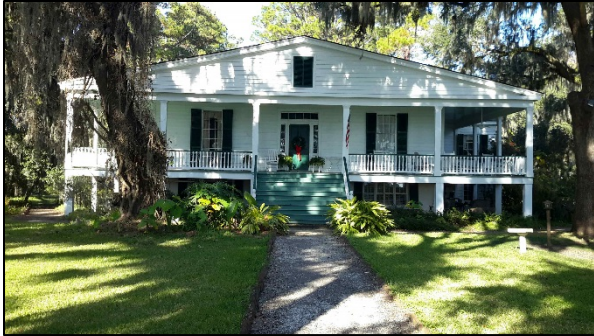
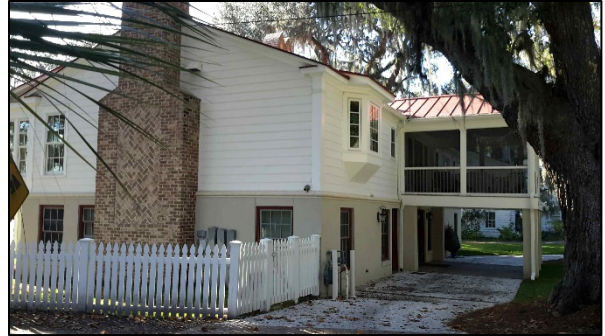
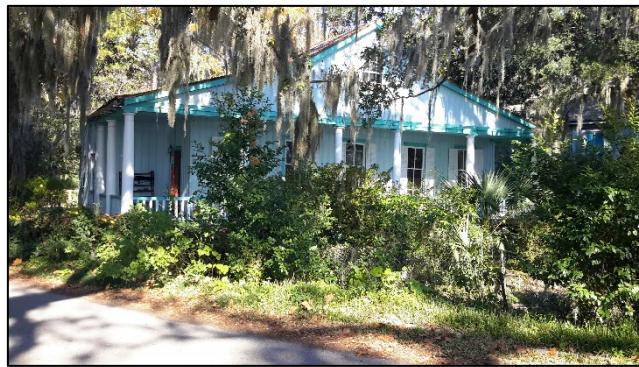
Example Properties in Repetitive Loss Area 15

Repetitive Loss Area 15 is located completely within the 100-yr floodplain. The Skidaway River flows directly south of this Repetitive Loss Area. The area is residential with a mix of crawlspace and piling with enclosure foundation types. One property owner has owned home for three years with no flood issues, but is aware of past flood issues approximately 20 years ago. This owner has recently renovated home including improving property's drainage by installing yard inlets. The neighbor says past flood damage here was due to poor drainage on property. Another owner has lived in their home since 1944 with no flood damage ever occurring.

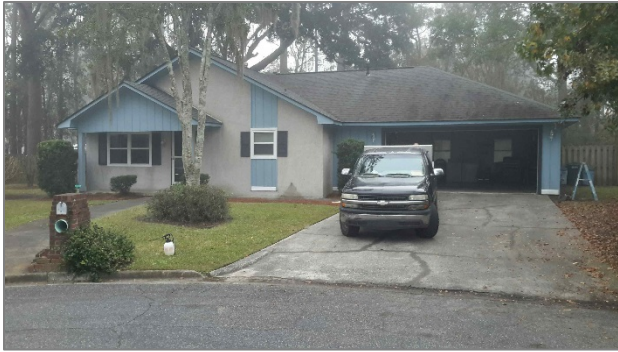
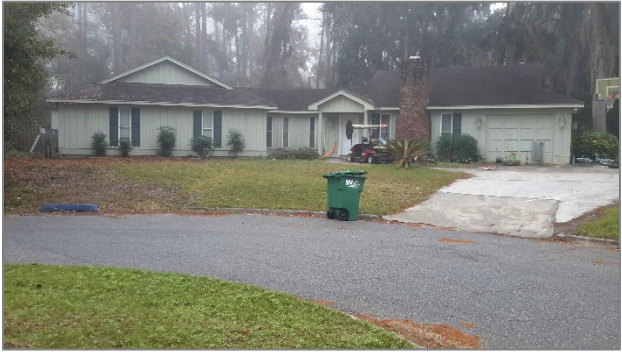
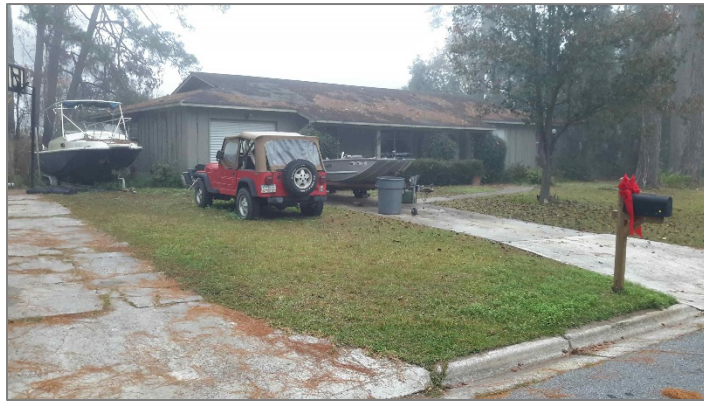
Example Properties in Repetitive Loss Area 16

Repetitive Loss Area 16 is located completely within the 100-yr floodplain. The Skidaway River flows east and south of this Repetitive Loss Area, and the Herb River flows north and west. The area is single-family residential with slab on grade foundation types. None of the homes have guttering.

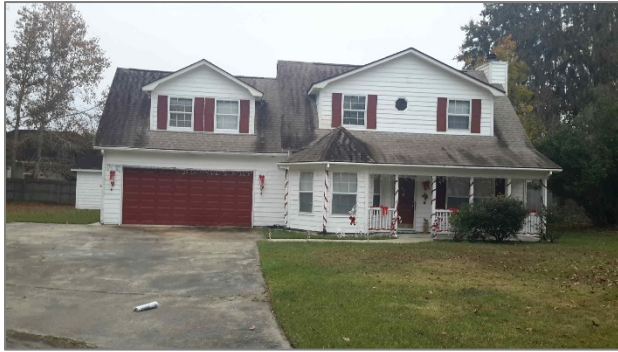
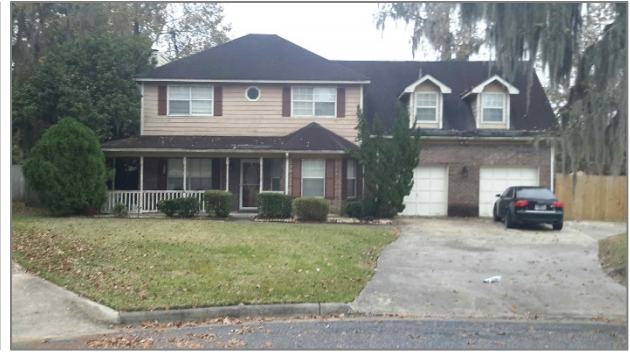
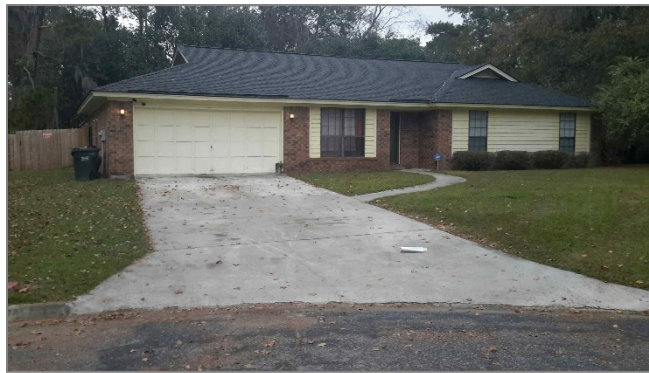
Example Properties in Repetitive Loss Area 24

Repetitive Loss Area 24 is located completely outside the 100-yr and 500-yr floodplain in the unshaded Zone X. A retention pond sits directly east of this Repetitive Loss Area. The area is residential with slab on grade foundations and a mix of masonry and wood frame construction. Several homes did not have guttering.

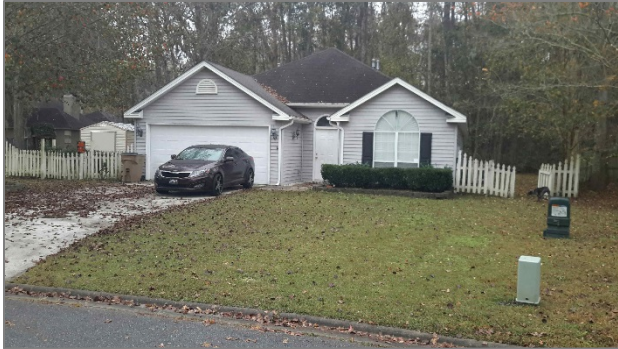
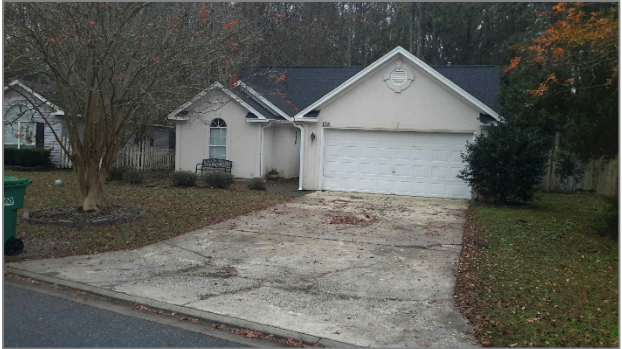
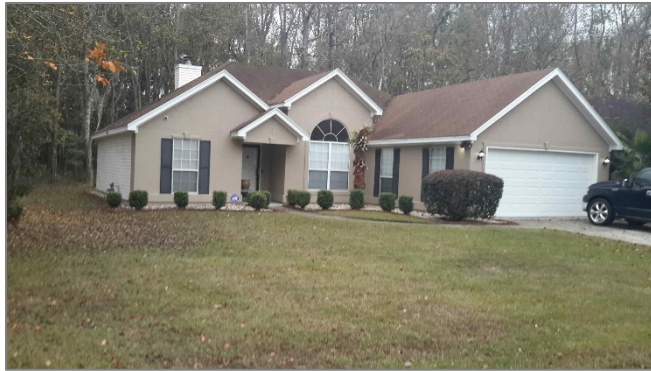
Example Properties in Repetitive Loss Area 25

Repetitive Loss Area 25 is located completely outside the 100-yr and 500-yr floodplain in the unshaded Zone X. The area is residential with slab on grade foundations and wood frame construction.

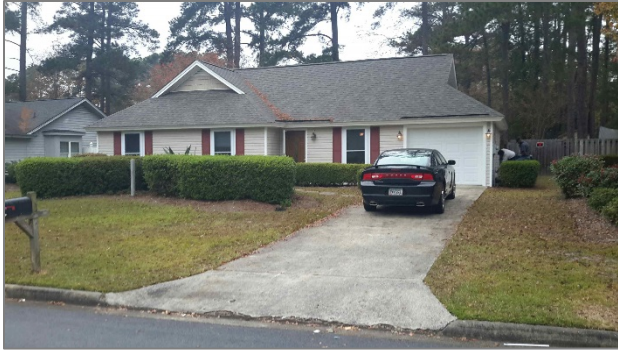
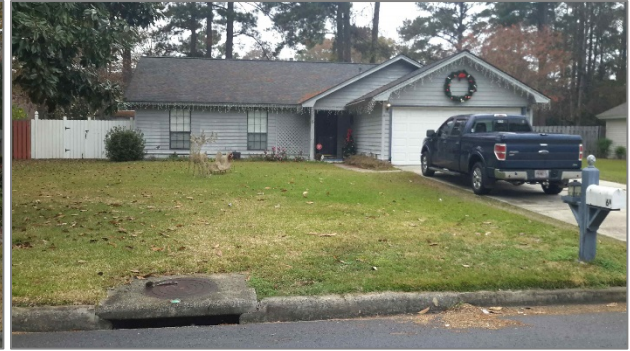
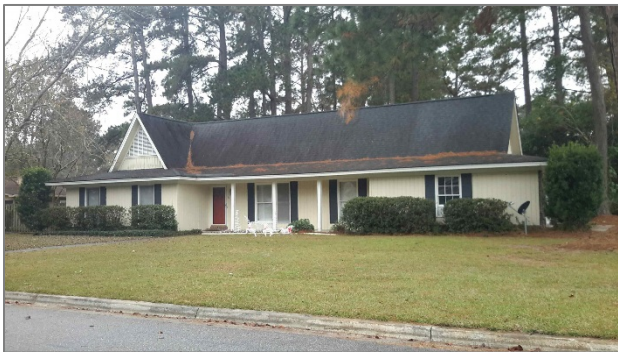
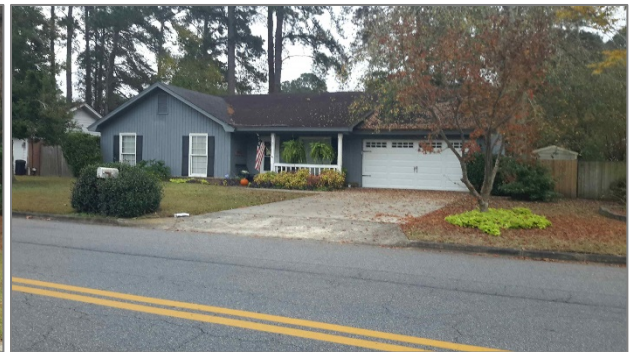
Example Properties in Repetitive Loss Area 26

Repetitive Loss Area 26 is located completely outside the 100-yr and 500-yr floodplain in the unshaded Zone X. The area is residential with slab on grade foundations and wood frame construction. Several homes did not have guttering. One property owner recently moved to the area and is unaware of any flood history or flooding issues.

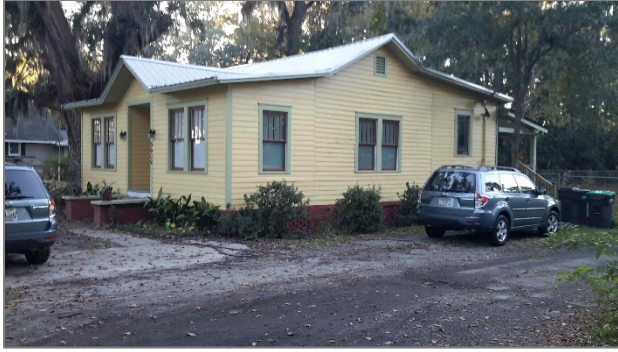
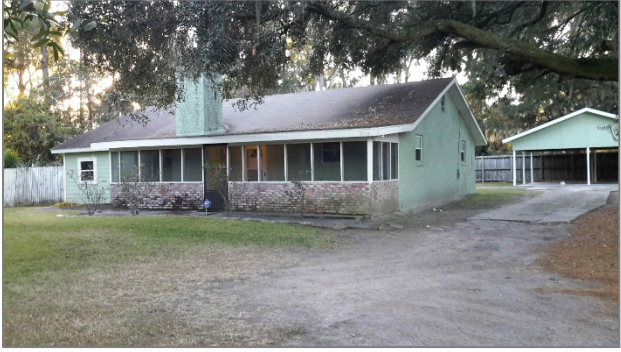
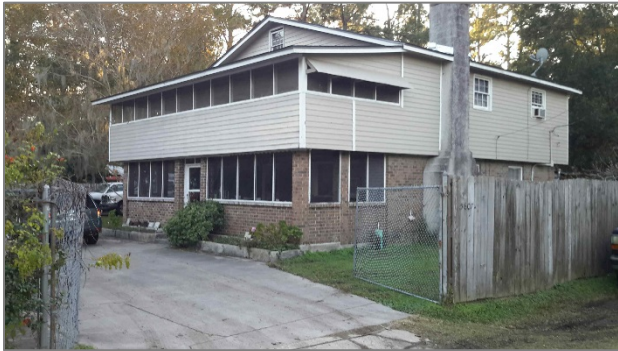
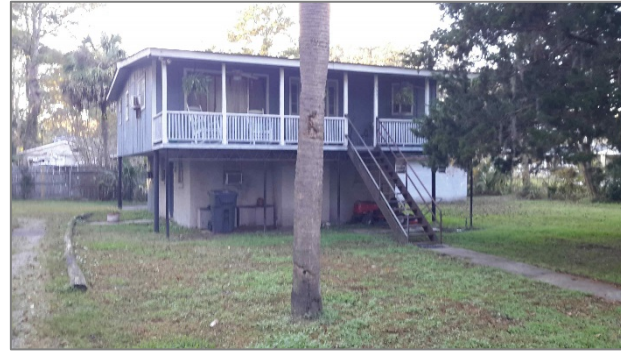
Example Properties in Repetitive Loss Area 12

Home on elevated foundation

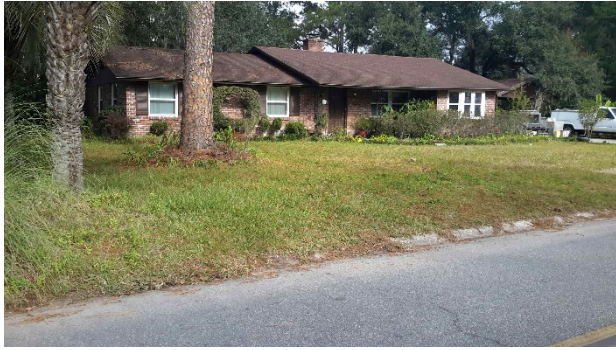
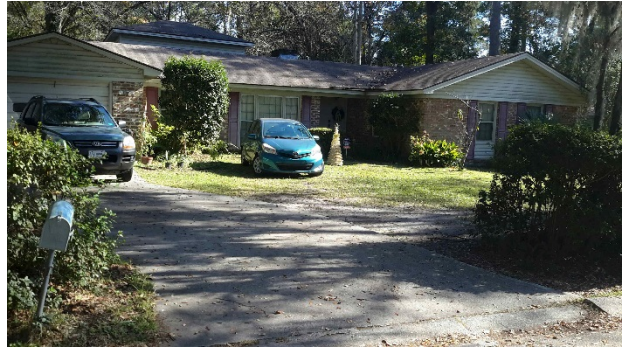
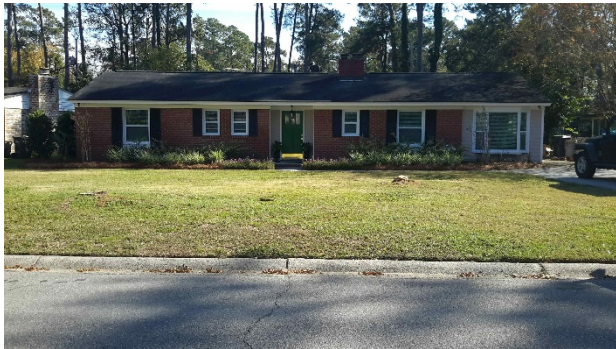
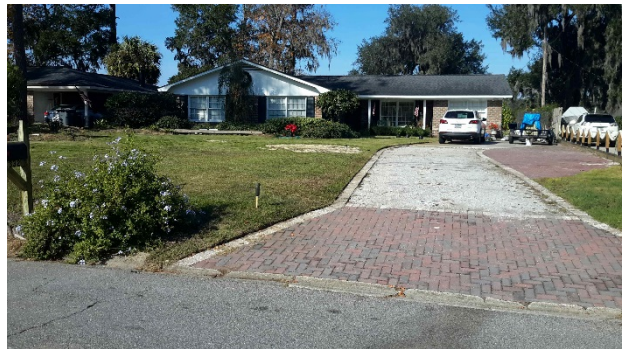
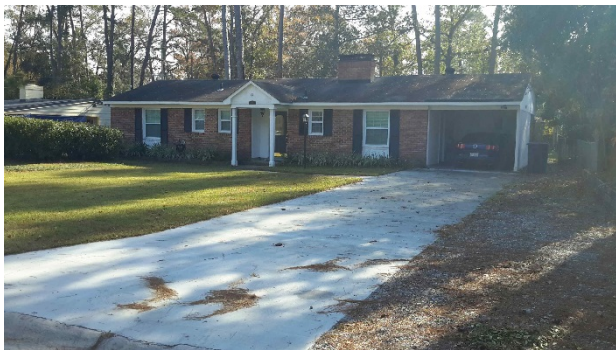
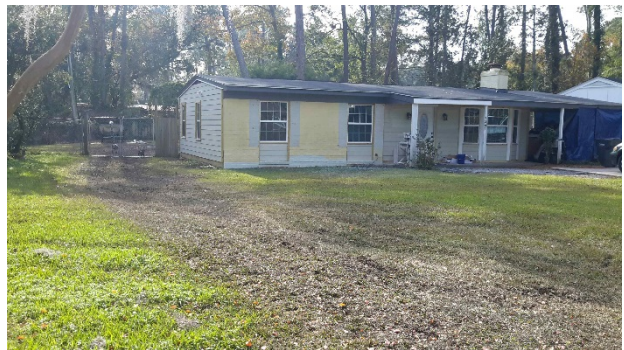
Example Properties in Repetitive Loss Area 20

Repetitive Loss Area 20 is located completely within the 100-yr and 500-yr floodplain. An unnamed tributary of the Vernon River flows directly north and west of this Repetitive Loss Area and is surrounded by marsh land. The area is single family residential with slab on grade foundation types. Some HVAC systems are elevated at least some amount up to the first-floor elevation, while others were observed at grade. All properties are built at grade. Hurricane Irma appears to have caused flooding throughout the neighborhood, including in properties that have not otherwise had flooding or drainage issues. One property owner of a house located near the highpoint of the street said they have never had any flooding issues. Another property owner stated they have not had flooding issues in their three years in the neighborhood. Another owner reported during the site visit that flooding had never been a problem but that during Hurricane Irma flood waters reached just below the doorway. A property undergoing repairs was flooded with about two feet of water during Hurricane Irma, according to a neighbor whose own property was flooded up to the front door. The latter property was at the low point of the street and the ground was wet. A nearby neighbor also reported flooding from Hurricane Irma, in their case about halfway up their driveway. Similarly, a property owner who has not had flooding in their 50 years owning their home experienced two to three inches of flooding during Irma. In survey responses, one property owner felt that a drainage ditch near their home is inadequate and does not allow for effective storm drainage.

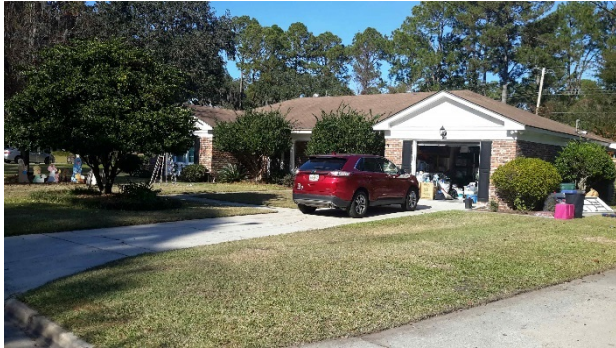
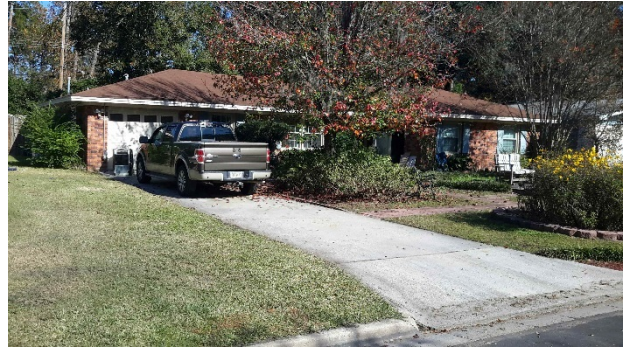
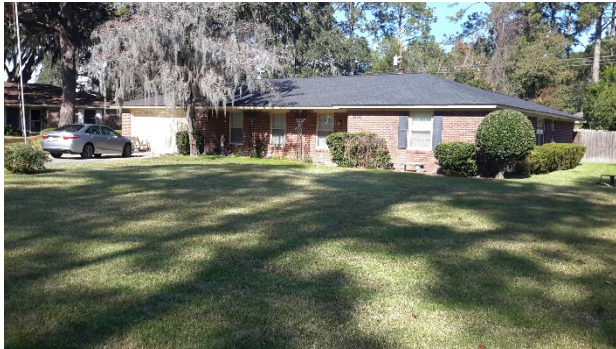
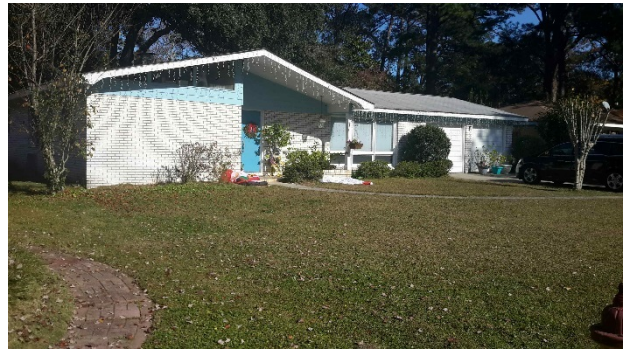
Example Properties in Repetitive Loss Area 21

Repetitive Loss Area 21 is located completely within the 100-yr floodplain. The Vernon River flows northwest of this area, with surrounding marsh land. The area is residential with slab on grade foundation types built at grade. Three of the four property owners in this area were available during site visits and reported that Hurricane Irma caused varying levels of flooding but that flooding had previously not been an issue with the exception of some stormwater issues in the street due to debris in the drainage system. The fourth property looked to be under repairs and thus was likely to also have experienced some flooding during Irma. In survey responses, one property owner reported flooding during multiple years and that flood issues have continued despite their re-grading their yard. This property owner suspects that the construction of the Truman Parkway has caused some problems by changing water dispersion in this area.

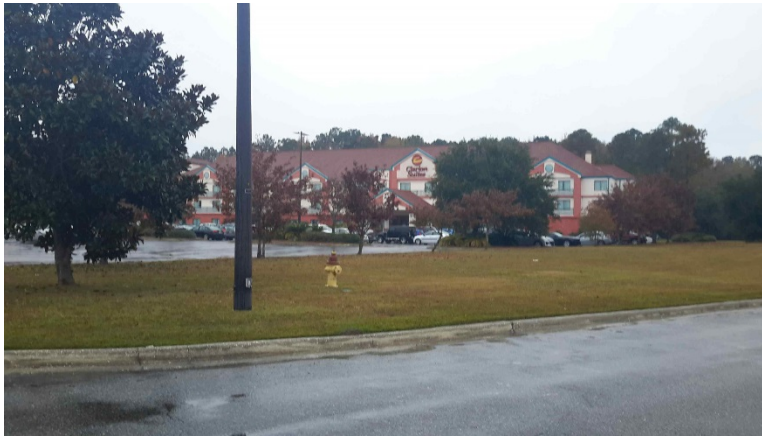
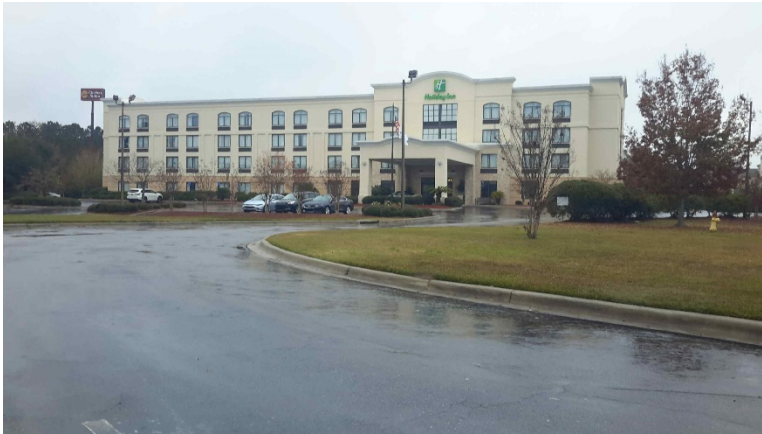
Example Properties in Repetitive Loss Area 28

Repetitive Loss Area 28 is located completely outside the 100-yr and 500-yr floodplain in the Unshaded Zone X. A drainage canal runs to the northwest of this area, between the properties and Interstate 95. The area is commercial with two multi-story hotel structures with slab on grade foundations and large parking lots. The manager of one of the hotels says it was built in 2002 and she is unaware of any flooding issues.
